**Flood Control Project Maintenance  
Levee Inspections**

**Fall 2009 Levee Maintenance Deficiency Summary Report**

**Reclamation District No. 0017 Mossdale**

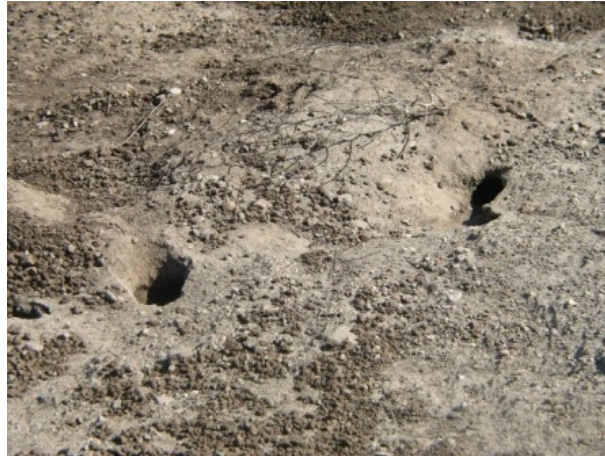
Levee Mile Report Line	3
Start Levee Mile	2.19
End Levee Mile	2.23
Location	Land Side
Category	Earthen Levee
Item	Animal Control
Squirrel borrows on landside slope heavy infestation from LM 2.19 to 2.60	
richard_20091216_129.jpg

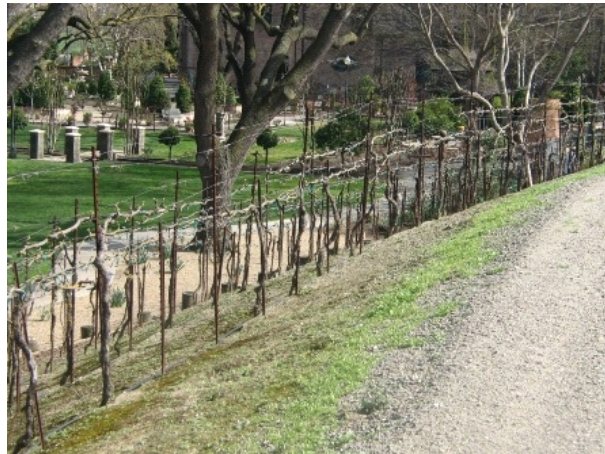
Levee Mile Report Line	16
Start Levee Mile	4.28
End Levee Mile	4.32
Location	Land Side
Category	Earthen Levee
Item	Encroachments
Grape vines on landside slope from LM 4.28 to 4.32	
richard_20091216_130.jpg

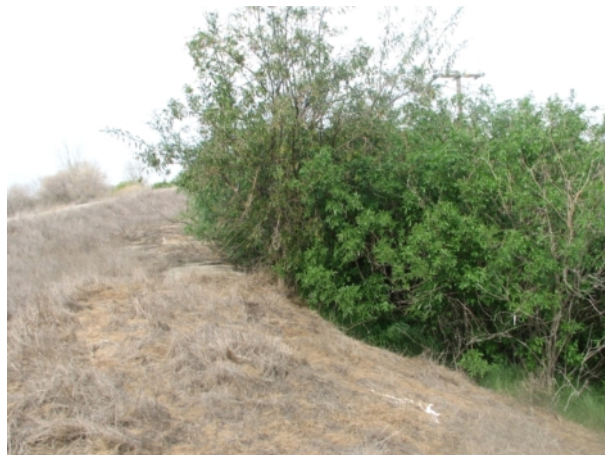
Levee Mile Report Line	40
Start Levee Mile	7.67
End Levee Mile	7.69
Location	Land Side
Category	Earthen Levee
Item	Vegetation
Elderberry blocking view of landside slope and toe from LM 7.67 to 7.69	
richard_20091216_134.jpg

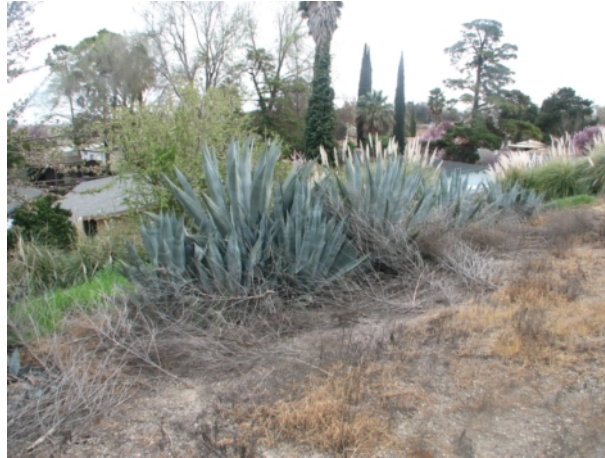
richard\_20091216\_136.jpg

Levee Mile Report Line	60
Start Levee Mile	13.66
End Levee Mile	13.66
Location	Land Side
Category	Earthen Levee
Item	Encroachments

Catus (Landscaping) on landside slope blocking view at LM 13.66
